ORIGINAL PAPER

Preliminary study of bipolar hip prosthesis – influence of acetabular bone interactions on bone morphology

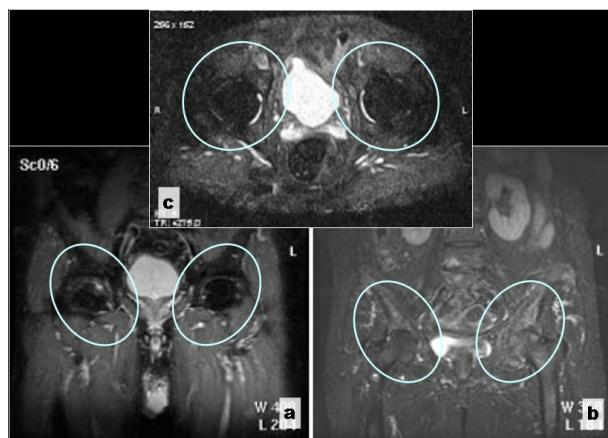
Calcifications of round ligament were present in some patients, expressed by hypersignal in T2 sequences (Figure 13c). We also identified, in some cases, areas of acetabular bone edema expressed by focal or diffuse hypersignal in STIR sequences (Figure 14).

Figure 14 – MRI STIR sequence: (a-b) Core; (c) Axial.

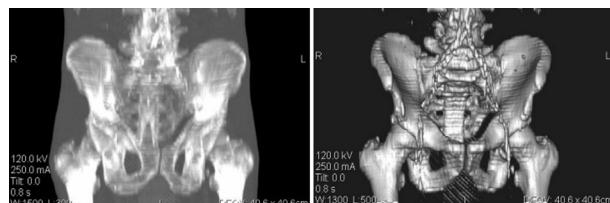
3D reconstruction on CT allowed us to determine the osseous densities (HU) in acetabular bone (Figure 16). It is known that only values below 500 HU have the meaning of a low-density bone structure, which is exposed to the risk of degeneration and fracture.

Figure 16 – CT 3D reconstruction of hip joints.

Osseous density had a wide range of variation, between 217 HU and 1211 HU both in control group and revision group. In the latter, HU values had a decreasing trend with the intensity and extension of degenerative changes.
